Urgent Field Safety Notice Product Correction

Product Name	List Number	Serial Number	UDI
Alinity c Cuvette Segment	04S47-01	All	Not applicable

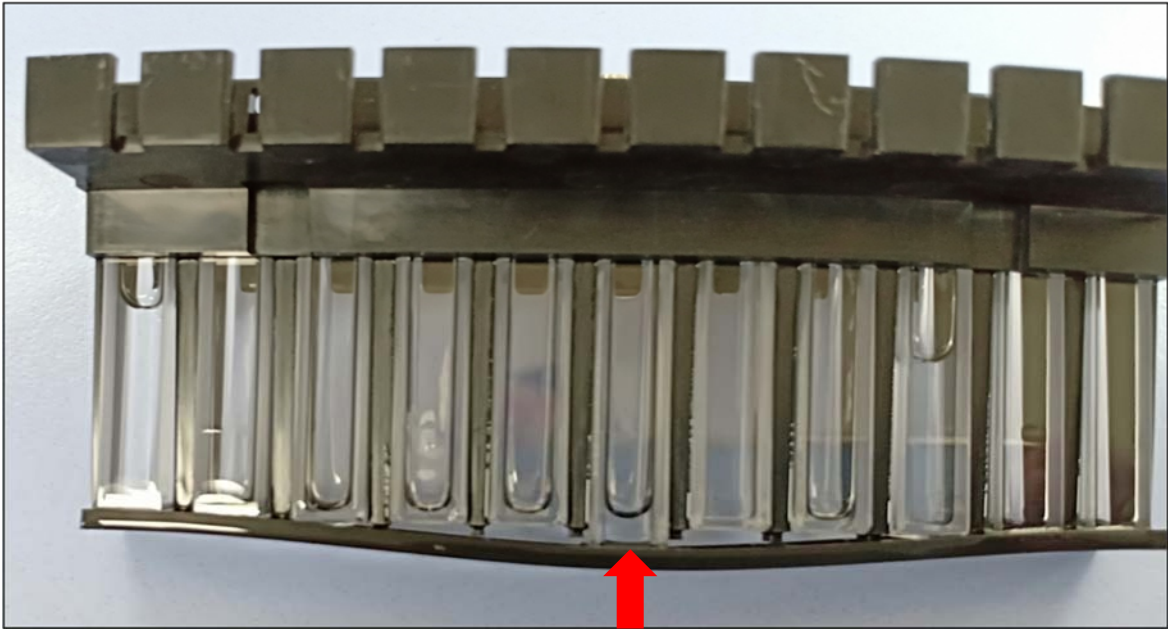
Individual cuvettes within the Alinity c Cuvette Segment may become seated lower than the designed height. This may result in inadequate dispense into specific cuvettes due to the sample probe being unable to make efficient contact with the cuvette bottom.

A cuvette may become seated lower than the designed height due to excessive force that causes damage to the sealant around the cuvette segment top or causes the cuvette segment base to detach. Excessive force is any force greater than normal operational forces exerted by the instrument, such as during manual cleaning of cuvettes or cuvette washer movement errors.

The following pictures show examples of Alinity c cuvette segments where cuvettes are seated lower than designed height:

The red arrow indicates where a cuvette is seated lower than it's designed height

- The cuvette segment base is detached.
- One or more cuvettes are seated lower than the other cuvettes in the segment.
- One or more cuvettes are damaged.

If damage is discovered, replace the damaged cuvette segments in the reaction carousel. Verify proper installation as instructed in Alinity ci-series Operations Manual 9: Service, maintenance and diagnostics: Component replacement, Replace the cuvette segments (c-series).
