# Urgent Field Safety Notice Product Correction

This Product Correction letter is to inform you of an issue with the ARCHITECT c Systems Mixer (LN 09D59-01, 09D59-02, and 09D59-03). There is the potential for the mixer blade, attached to the mixer with a screw and nut, to separate from the mixer. The missing mixer blade will result in inadequate mixing of the reaction mixtures leading to potential incorrect results (failed assay calibration, Quality Control (QC) out of range, and/or incorrect patient results). The impact on the test result may vary depending on the assay being performed and the viscosity of the patient sample.

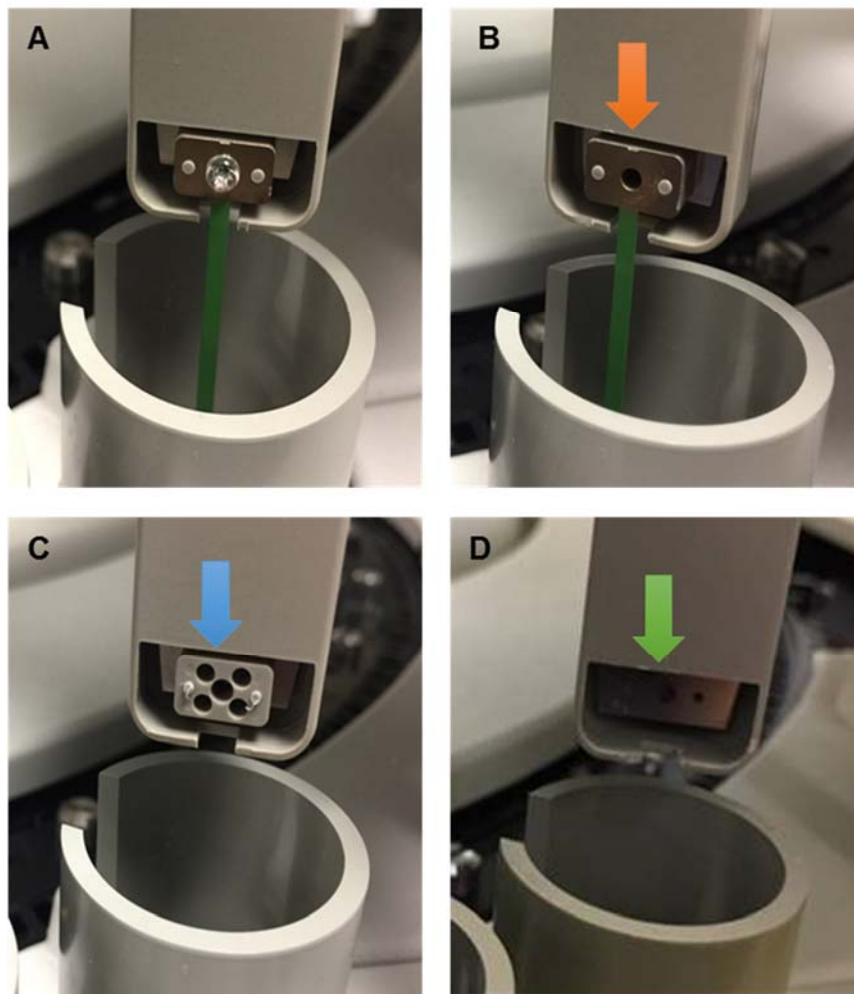
The following pictures show a A) normal mixer B) mixer missing the mixer screw (orange arrow pointing to missing screw), C) missing mixer blade with spacer shim present (blue arrow pointing to missing mixer blade), and D) missing mixer and spacer (green arrow pointing to missing mixer blade and spacer).

1. Replace broken mixer. Refer to *Replace the Mixer (c4000, c8000, c16000)*<sup>1</sup>.
2. Replace the cuvette dry tip. Refer to *Replace the cuvette dry tip (c4000, c8000, c16000)*<sup>1</sup>.
3. Follow the instructions in **Appendix C** to inspect all cuvettes to ensure that the screw or nut did not fall into an individual cuvette.
