## Urgent Field Safety Notice Product Correction

March 7, 2019

Product Name	List Number	Serial Number	UDI
Alinity ci-series System Control Module (SCM)	03R70-01	All	N/A
Level Sensor, Bulk Solution	04S68-01	All	N/A
Accessory kit, Alinity i	03R66-01, 03R66-02	All	N/A
Accessory kit #2, Alinity c	03R69-01, 03R69-02	All	N/A

#### Alinity ci-series issues resolved in software version 2.6.0

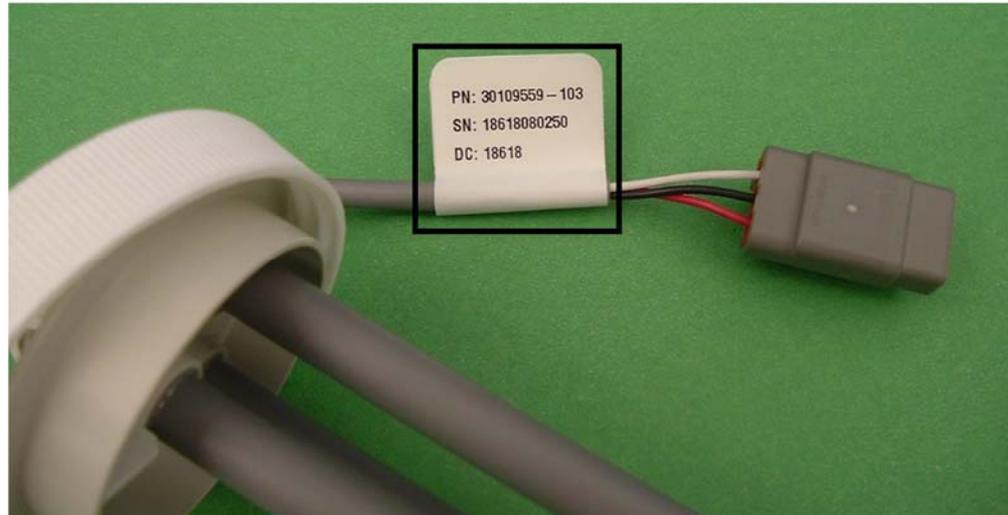
Figure 1. Level Sensor, Bulk Solution identification label

- If the part is in the box, the list number (04S68-01 or 04S68-02) is printed on the label
- If the part is removed from the box or installed on the Alinity ci series, the part number is printed on a label attached to the electrical connection for the part. See Figure 1 and Table 1 below.

List Number (LN)	Part Number (PN)	Instructions
04S68-01	30109559-102	Remove and replace any Level Sensor, Bulk Solution, LN 04S68-
04S68-02	30109559-103	01/PN 30109559-102 with LN 04S68-02/PN 30109559-103

If a bulk solution level sensor requires replacement, refer to the appropriate replacement procedure in Section 9 of the Alinity ci-series Operations Manual:
