**SIEMENS SOMATOM Definition AS**  
**SIEMENS SOMATOM Definition DS**  
**SIEMENS SOMATOM Definition Edge**  
**SIEMENS SOMATOM Definition Flash**  
**SIEMENS SOMATOM Force**

## Customer Safety Advisory Notice CT053/17/S

**Re: CARE Dose4D algorithm – Risk of unnecessary radiation exposure for head scans based on p.a./a.p. topograms**

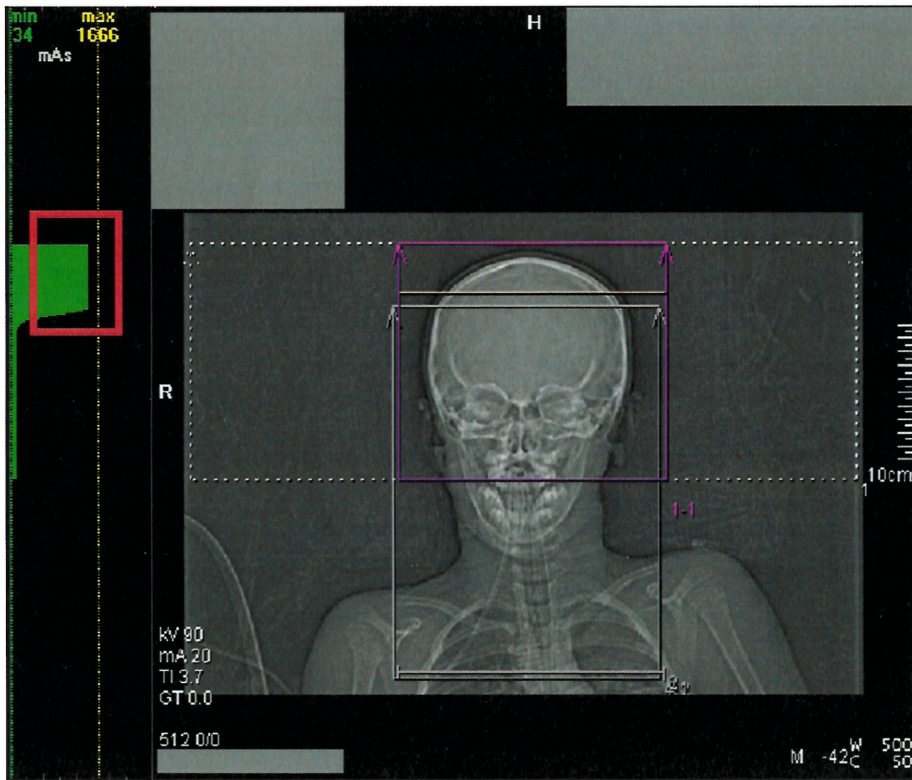
Siemens Healthcare became aware of possible incorrect tube current calculations by the CARE Dose4D algorithm for head scans based on p.a. (posterior-anterior) or a.p. topograms. Depending on the geometrical shape of the skull bone, it may happen in rare cases that the calculated dose distribution is not appropriate. Potentially, the CARE Dose4D software will select the maximum tube current for the uppermost part of the skull, thus leading to unnecessary radiation exposure.

The calculated mAs profile (= dose profile) of the planned scan range is displayed after performing the topogram on the left side of the screen (Fig. 1).

Any unusual dose distribution similar to the graph reflected in Fig. 1 indicates a possible malfunction of the CARE Dose4D algorithm. The very sudden and strong increase of the tube current in the upper part of the skull is easily recognized (Fig. 1, red rectangle).

Fig. 1 Topogram with calculated mAs profile

The described issue will not occur when using a lateral topogram instead of a p.a. or an a.p. topogram. Accordingly, we strongly recommend using topograms in lateral position for all head scans.

In case the operator becomes aware of the described behavior of the system, the scan should not be started. If the dose distribution appears to be incorrect, please run a new lateral topogram and check the dose distribution again!

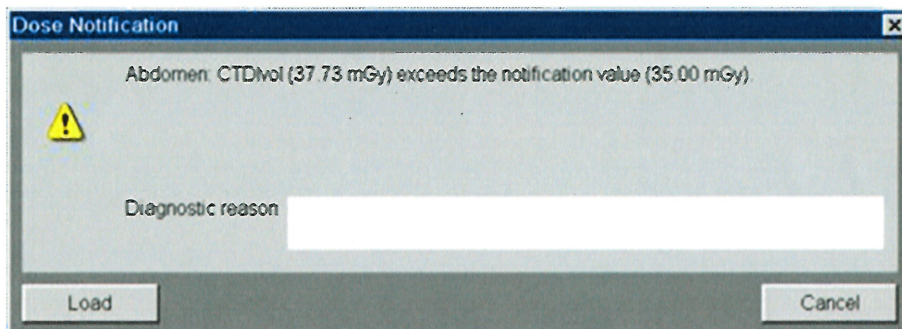
Furthermore, the user can configure dose notification thresholds for every scan range (please refer to the "Instructions for Use", chapter 9 "Dose management and optimization", subchapter 9.1.1 "Dose Notification"). If a dose notification threshold is configured and is bound to be exceeded, a notification requesting a confirmation by the user pops up prior to the scan (Fig. 2)

Fig. 2 Pop up window "Dose Notification" in case a configured threshold is exceeded
