**URGENT FIELD SAFETY NOTICE
MEDICAL DEVICE CORRECTION
FSCA 2249723-05/05/2023-008-C**

Datascope Cardiosave Hybrid and Rescue Intra-Aortic Balloon Pumps (IABP)

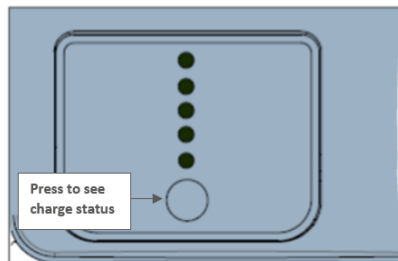
Figure 7: Not Actively Charging
 Press button to view charge status

- At the completion of the charging operation, all 5 LEDs will be lit briefly and then go dark.
- Always verify the state of charge by pressing the button below the LEDs on the front of the battery.
- If all 5 LEDs are not lit after pressing the button, the battery charging operation was not successful.
