## URGENT FIELD SAFETY NOTICE MEDICAL DEVICE CORRECTION FSCA 2249723-06/02/2023-009-C & FSCA 2249723-06/02/2023-012-C

Datascope Cardiosave Hybrid and Rescue Intra-Aortic Balloon Pumps (IABP)

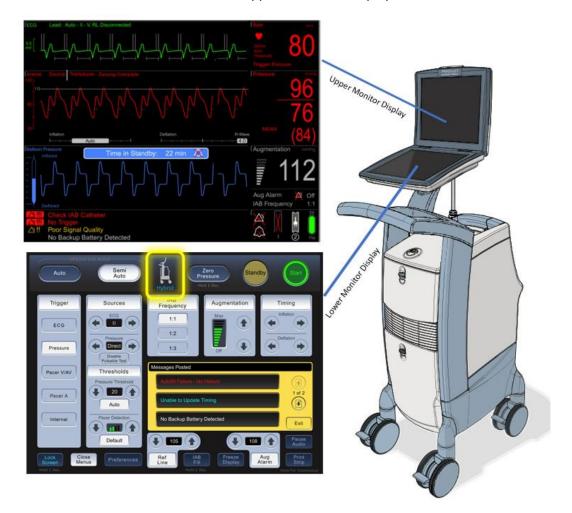
#### Cardiosave Upper and Lower Display

In both cases, information is provided to the user that the system is not in Hybrid mode via the Rescue Mode Icon on the bottom Cardiosave screen (top center of the screen). In addition, the "battery in use" message will be displayed in the informational message area even if the AC power cord is plugged in.

Additionally, in both scenarios, the Cardiosave will not receive AC power and if the device is in operation, it will continue to operate on battery. When the Cardiosave is not receiving AC power, the batteries are unable to charge.

If the AC Plug Icon is not present and/or the Rescue Icon is present, release the latch on the Hospital Cart located below the Pump Console, then grab the handle and slowly slide out the console approximately one quarter of the way.

Grab the handle and slowly slide the Pump Console into the Hospital Cart until it locks into place. You will hear an audible click noise and three audio tones of increasing volume will sound once the console is locked into the Hospital Cart.

To ensure the Pump Console was successfully installed into the Hospital Cart, plug the Hospital Cart power cord into a compatible grounded AC receptacle, and confirm AC operation by checking the battery icon to confirm the pump is using AC power.

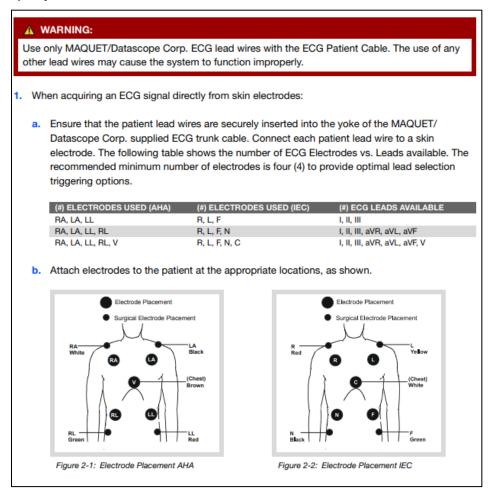
Factors Contributing to ECG failure:

- Poor Quality Skin-Electrode Interface
- Front End PCBA Failure including Wetting (causes system to be unable to detect ECG lead faults)
- Faulty ECG Lead
- Failure of Executive Processor Board (the system cannot obtain or interpret the ECG)
- Defective ECG Lead Wire
- Defective Trunk Cable
- Defective connector between ECG cable and IABP unit

The type of skin electrode and application technique are major factors in determining the quality of the signal obtained. Use of high quality electrodes is recommended. These are designed to acquire an ECG signal with excellent baseline stability, recovery from defibrillation and minimum artifact from patient movement. The use of Wet-Gel electrodes is recommended because, in general, they provide a better quality electrical contact immediately after being placed on the skin.

To ensure the safe and effective use of the Cardiosave IABP, follow the recommendation in the IFU, including the warning and Figures 2-1 and 2-2 regarding ECG lead placement locations and the use of third-party lead wires.
