**URGENT FIELD SAFETY NOTICE
MEDICAL DEVICE CORRECTION**

MAQUET CARDIOSAVE hybrid and MAQUET CARDIOSAVE rescue

Product Code/Part Number:	0998-XX-0800-XX
Distributed Affected Lot Number:	All
Distribution Dates:	Since March 6, 2012

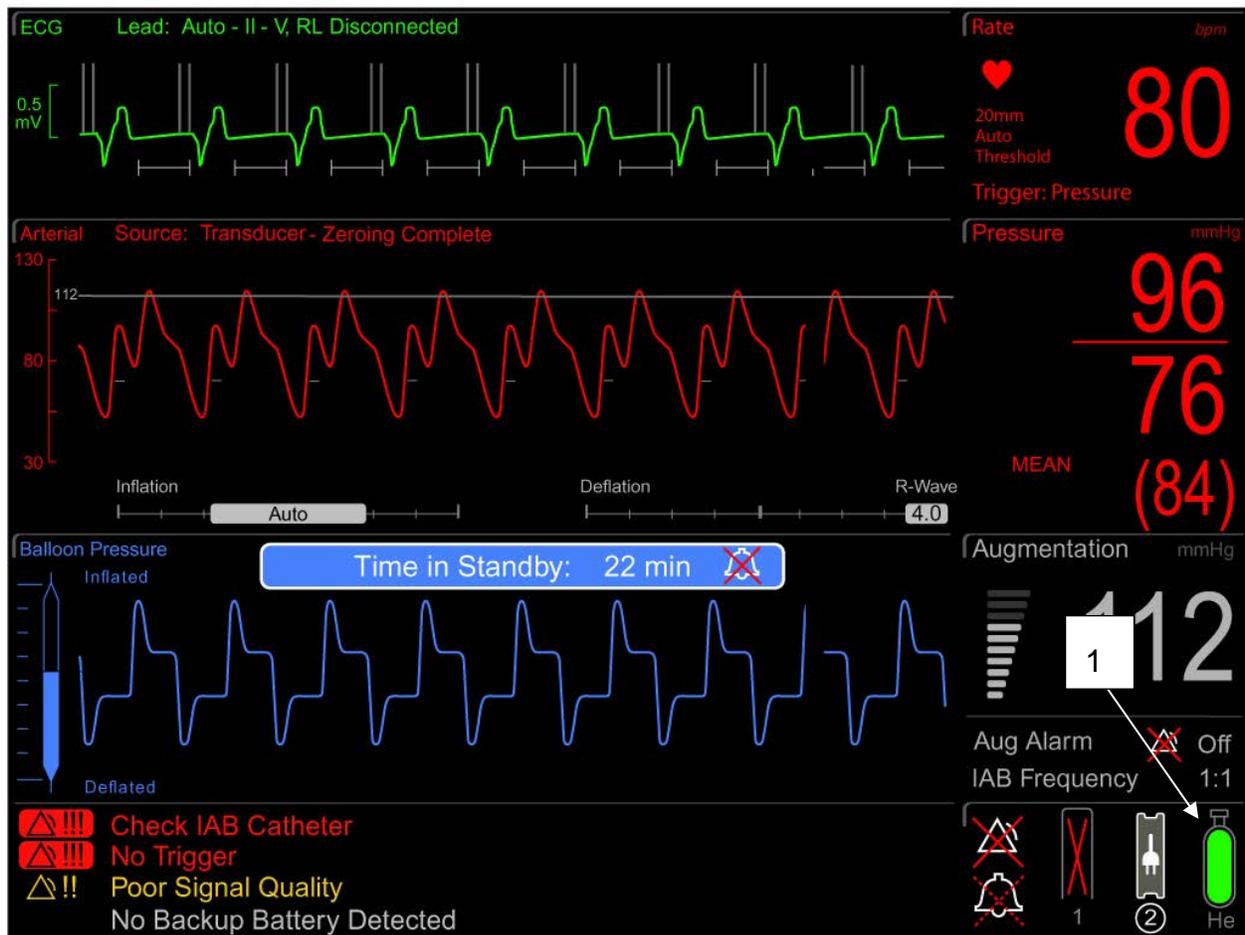
Figure 1 – Monitor Display (1 – Helium Indicator)

During Electromagnetic Compatibility (EMC) testing at an external lab, Getinge personnel determined that in the presence of some radiated RF disturbances, the Helium Indicator on the Cardiosave IABP (refer to Figure 1) would intermittently over-report the remaining Helium Capacity. Once the disturbance was removed the Helium indicator always fully recovered within 10 seconds to display the proper level without any over-reporting.

Getinge’s investigation revealed that the over-reporting of Helium Capacity would intermittently occur at frequency ranges between 80 MHz – 1 GHz. Potential sources of interference include: radio communication, cell phone, Wi Fi, RFID equipment and equipment that does not meet current electromagnetic compatibility standards.

It is important to note that upon removal of the source of EMC interference the Helium Indicator performs as intended.

Datascope/Getinge is developing a hardware correction to address this issue. A Datascope/Getinge service representative will contact you to schedule the installation of the correction when available. This work will be done at no cost to your facility.

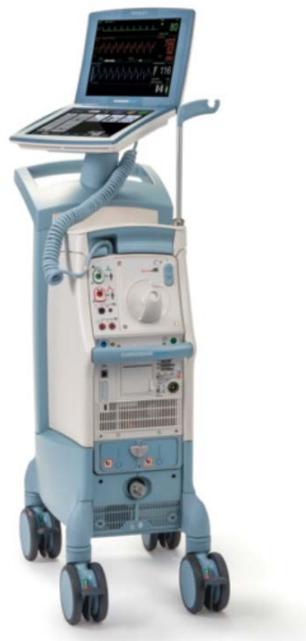
Figure 3: Cardiosave in Hybrid Configuration

The Cardiosave IABP may unexpectedly shut down when the device is running on AC power, only one battery is installed in the IABP, and the battery is physically removed while the battery is being charged. An audible sudden shutdown alarm will sound if this condition occurs. This issue can only happen in the presence of clinical personnel as the battery must be physically removed.

Unexpected shutdown can only happen while in Hybrid Configuration (Figure 3) when all four of the below conditions are met:

1. IABP is running on AC power and charging a single battery in voltage charging mode. Voltage charging mode occurs during the last 15-20 minutes of the full charging cycle, when the 5th and final LED charge indicator on the battery pack is flashing.
2. The other battery bay is empty, i.e. no battery is inserted into the second battery bay.
3. The battery is ejected while a system signal erroneously reports the AC power supply is low, this will only happen intermittently when the first two conditions are met.
4. Battery is ejected when all above conditions are met.

To ensure that the Cardiosave Hybrid is not susceptible to the shutdown during the removal of a battery, users should not eject a battery when:

- There is a singular battery in either battery charging bay and unused battery bay is empty.
- The battery is charging on AC power (indicated by a flashing LED on the battery pack).

Additionally, the user can prevent the issue by ensuring that a battery is inserted into each of the two battery bays. Should a charging battery be ejected inadvertently, the unit will automatically switch over to the second battery, thus preventing system shutdown.

Furthermore, Datascope/Getinge is developing a software correction to address this issue. A Datascope/Getinge service representative will contact you to schedule the installation of the updated software. This work will be done at no cost to your facility.

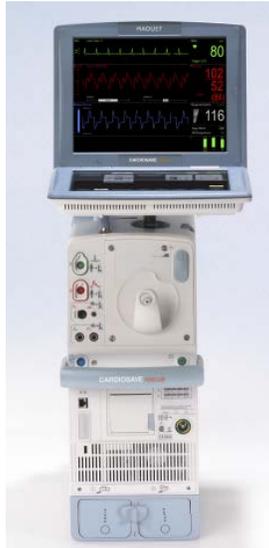
Figure 4: Cardiosave in Transport Configuration

An unexpected shutdown upon battery removal cannot occur for Cardiosave Rescue.
