Welch Allyn, Inc. 4341 State Street Road Skaneateles Falls, NY 13153 USA	URGENT: Field Safety Notice	MOD1329
---	------------------------------------	----------------

WelchAllyn GS777 Wall Transformer (all models) and PRO BP 3400 (handheld, desk mount, wall mount models)

Field Safety Notice

Subject: GS777 Wall Transformer and ProBP 3400 Potential Fluid Ingress (MOD1329)

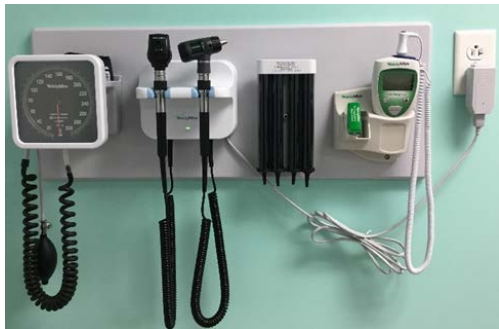
GS777 Wall Transformer

There is a risk of an internal electrical short and possible electrical shock occurring if cleaning fluid ingresses into the power supply, and the power supply is plugged into the electrical outlet before the cleaning fluid has completely dried. This notice is being distributed to make users aware of this potential risk and provide instructions for appropriately cleaning the power supply. The WelchAllyn GS777 is a device that is mounted either on the wall or on a mobile stand. It holds and supplies power to small handheld devices such as ophthalmoscope and otoscope heads. The ProBP 3400 Blood Pressure Device (all models) is a digital blood pressure device that can be used in a handheld, wall-mounted, or mobile configuration.

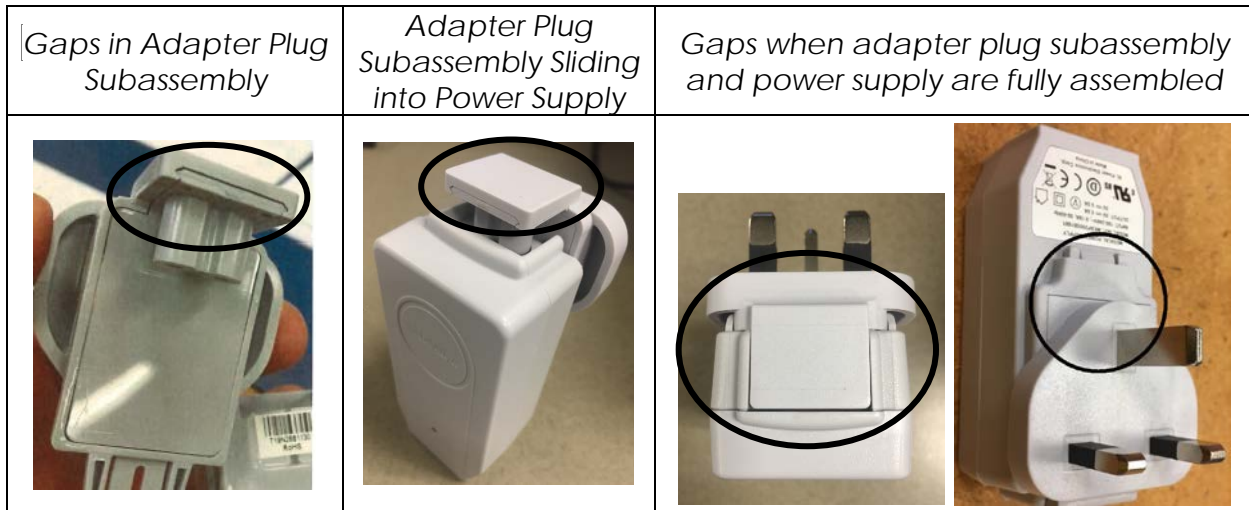
Our investigation has confirmed that the reported complaints were the result of unintentional fluid ingress into the power supply caused during cleaning.

Based on our investigation, unintentional fluid ingress is most likely to occur in the gaps of the adapter plug subassembly pictured below.

The GS777 and the ProBP 3400 power supplies are not intended to be cleaned with saturated wipes and should not be plugged into an electrical outlet when wet.
