Broj: CAPA00776

## Sigurnosna obavijest

***Urgent Field Safety Notice for:  
Dako Autostainer Instruments (AS480; AS100; S3800; S3400):***

**Update of Autostainer Link Basic User Guide to reduce risks of staining issues due to leakage**

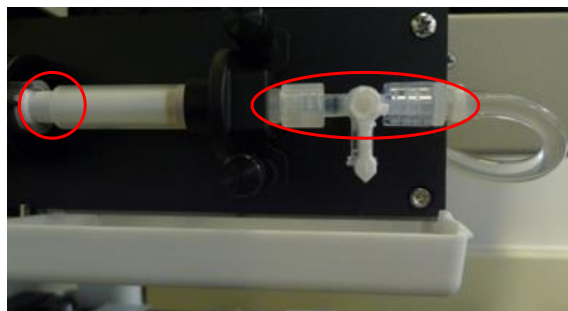
Visually Inspect the syringe tray, syringe and stopcock for salt residues and/or liquid, see picture below. If there are signs of unexpected salt residues and/or liquid, contact your local Agilent Technical Service representative as this might indicate a leakage in the system.

Visually inspect the syringe tray, syringe and stopcock, areas highlighted in red, for signs of unexpected leakage (salt residues and/or liquid).

If there are signs of unexpected leakage (salt residues and/or liquid), contact your local Technical Service representative immediately as this might indicate a leakage in the system.

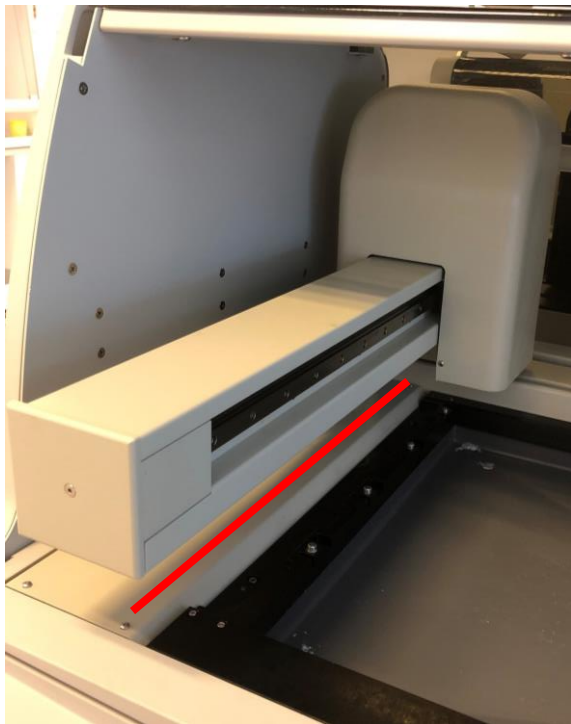
Visually inspect the left plate, area highlighted in red, for signs of unexpected leakage (salt residues and/or liquid). This might indicate leakage from the robotic arm.

Visually Inspect the left plate, and the area around the wash station for salt residues and/or liquid, see pictures below. If there are signs of unexpected salt residues and/or liquid, contact your local Agilent Technical Service representative as this might indicate a leakage in the liquid system. If leakage is observed, the slides from the run just completed must be closely reviewed for staining abnormalities.”

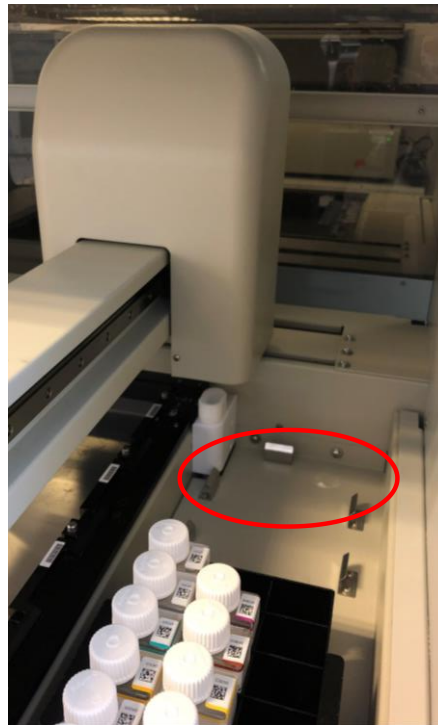
Visually inspect the area around the wash station, area highlighted in red, for signs of unexpected leakage (salt residues and/or liquid). This might indicate leakage from the z-head or too high pump pressure.
