URGENT FIELD SAFETY NOTICE

**Out of Specification Proboscis/Piston Assembly for
VITROS 5,1 FS/XT 3400/4600 Chemistry Systems, VITROS 3600
Immunodiagnostic Systems, VITROS 5600/XT 7600 Integrated
Systems May Not Perform as Intended**

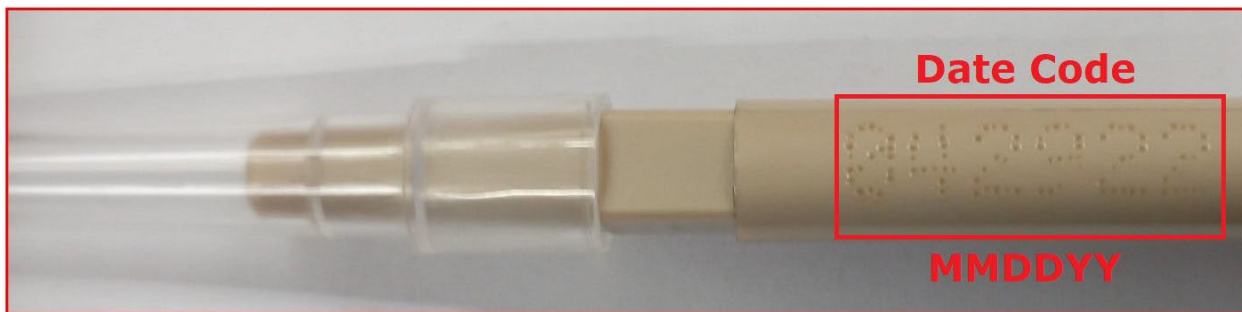
QuidelOrtho confirmed the issue and determined that certain Proboscis/Piston Assembly (or Assemblies) manufactured between 07-Apr-2022 (Date code: 040722) and 19-Dec-2022 (Date code: 121922) may not perform as intended due to an out-of-specification barrel component. This may cause VITROS® VersaTips and/or VITROS® MicroTips to be improperly seated on the barrel component of the Assembly, which may result in an increased frequency of condition codes related to the actions of tip pickup, aspirate, dispense, mix, tip-seal, and discard. Due to the small VITROS MicroTip and VersaTip dimension variability (within manufacturing tolerances) and the way these Tips interact with the Assembly, Assemblies manufactured within the affected date range may not perform as intended based on the Tips currently in use.

To determine if your laboratory is using an Assembly that was manufactured within the affected date range, check the date code stamped into the barrel of the Assembly. Refer to the example image below to locate the date code on the barrel component of the Assembly.

If your laboratory has an Assembly with a date code between 040722 - 121922, the Assembly is considered affected and must be replaced.

- Determine if any of the impacted VITROS Systems in your laboratory are using an affected Proboscis/Piston Assembly by checking the date code stamped into the barrel component. Once a replacement Proboscis/Piston Assembly is received, discard all affected Assemblies within the date range of 040722 - 121922.
