**FSN Ref:** 2026-FSN-0000143

**Date:** 2026-06-30

**URGENT Field Safety Notice**  
**Introducer for Impella (sold within Impella Pump Sets and**  
**Individually Packaged)**

**URGENT Field Safety Notice (FSN)**  
**Risk of Leakage when using Purge Cassette Gen 1**

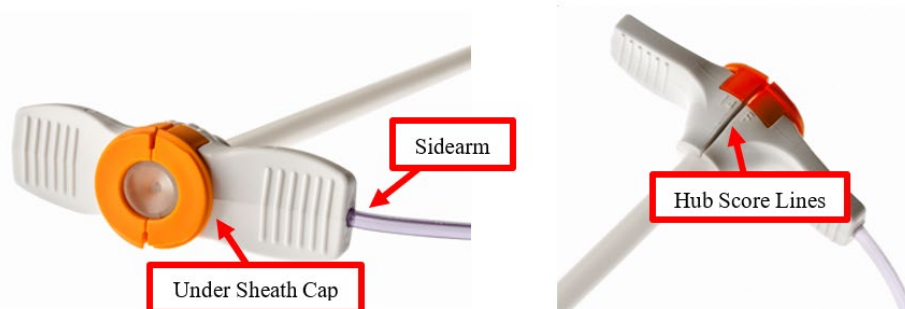
| 1. Information on Affected Devices* | |
|---|---|
| | Abiomed has identified a potential for 14 and 23 Fr introducer sheath leakage from the sidearm, under the sheath cap and along the hub score lines in the hub region. The unexpected leakage in these specified locations is due to certain manufacturing related issues, which increase the risk of access-site bleeding. Abiomed, in collaboration with its manufacturing partner (Oscor), has initiated containment, correction, and corrective/preventative action activities to address the issue. |

If this issue were to occur, the user would see blood loss at the sidearm and hub of the introducer sheath as shown below on the 14Fr introducers. Leak locations are the same for both 14Fr and 23Fr introducers.

Areas where users may see blood loss from the sidearm and hub region:

- Product removal is not required, and hospitals may continue to use existing inventory. Physicians should continue follow the IFU, use appropriate clinical awareness, monitoring, and patient support as needed. Consider a device exchange or using the repositioning sheath to minimize blood loss if potential leakage from the sidearm and under the sheath cap and along the hub score lines in the hub region is observed.
