Urgent Field Safety Notice

BiPAP Tubing – risk of patient harm as a result of the tubing separating from the purple cuff connector.

Devices: Anaesthetic Circuit, AquaVENT® CPAP System, Ventilator Circuit for Non-invasive Ventilation

Date of Issue: 19 Dec 2025

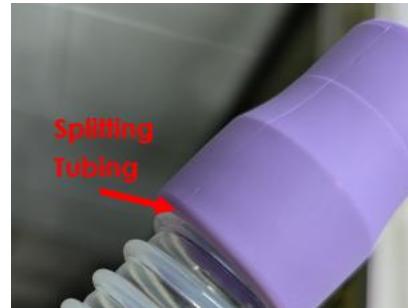
This IFU update follows receipt of seven (7) reports from customers stating that there have been tears occurring between the tubing and the purple cuff connector when disconnecting to replace the filter, resulting in a delay to treatment and/or the need to replace the entire circuit. You are receiving this FSN because Armstrong records indicate that these devices were shipped to your facility.

Pulling on the tubing may lead to inadvertent tubing separation from the purple cuff connector. Replacement of the circuit may result in delays in treatment and will require intervention by Healthcare Professional. These situations present a potential risk of

1. Do not disconnect the circuit by pulling on the tubing. Always disconnect by holding the purple cuff connector and pulling the breathing filter gently.
2. When connecting a breathing filter do not push excessively in to the purple cuff connector. Push to the point of resistance and ensure the breathing filter can be easily attached and detached from the breathing circuit/tubing during setup before proceeding.

1. Check all circuits currently in use to ensure there are no signs of tubing separation from the purple cuff connector.
2. When changing the breathing filter, hold the purple cuff connector securely whilst gently pulling on the filter to remove. Do not pull on the tubing.
3. When adding a new filter, push the filter into position gently until reaching the point of resistance. Do not push the purple cuff connector excessively onto the breathing filter.
4. Pass and post this notice for all who need to be aware within your organisation or to any organisation where the potentially affected product has been transferred or distributed.
