**RANDOX**  
**Urgent Field Safety Notice**

**Date Issued:** 06 Sep 23

**Complaint Reference:** REC687

**Action Type:** Device Modification

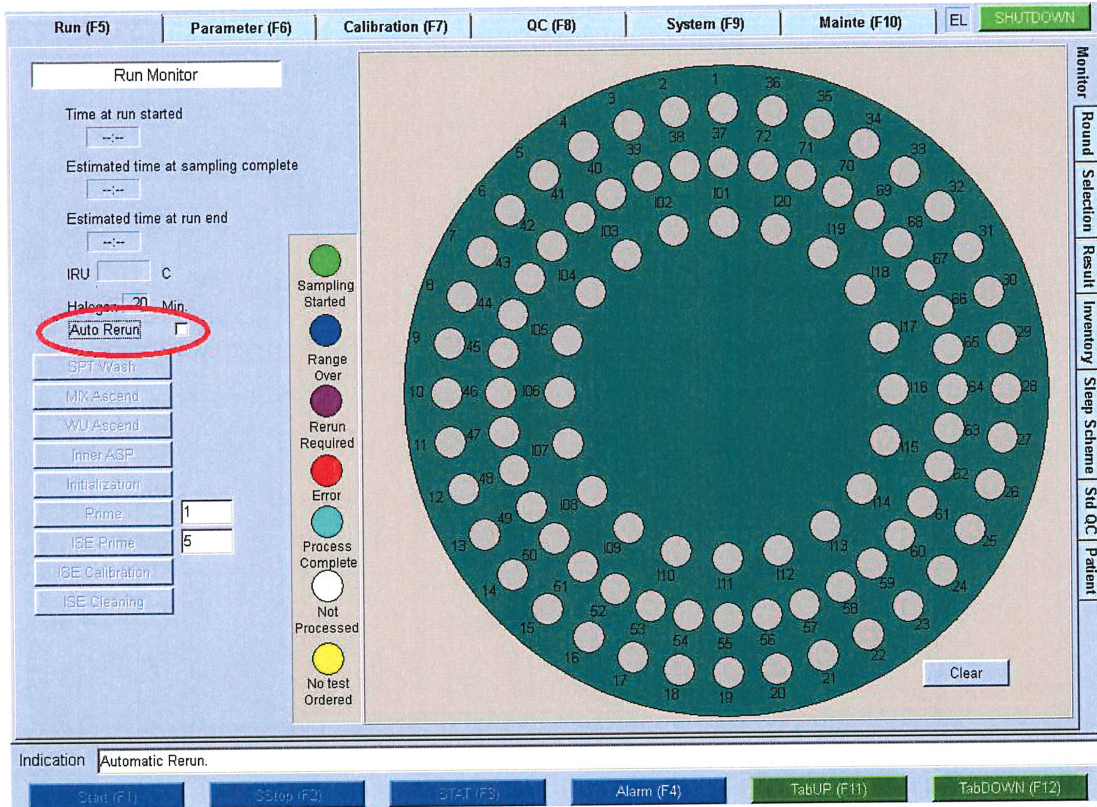
Rx Imola:

Ensure this box is unticked.

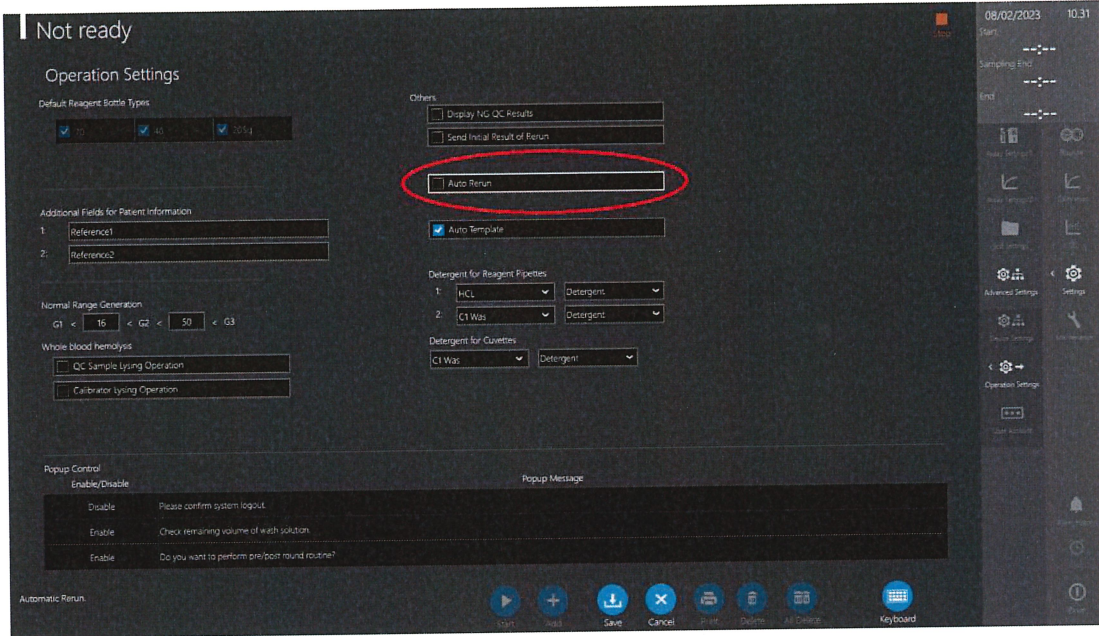
Rx Modena:

Ensure this box is unticked.
