# **Urgent Safety Information**

## **Field Corrective Action**

## **Avantgarde 4 and Zenit**

**Referenz: 260311-1035**

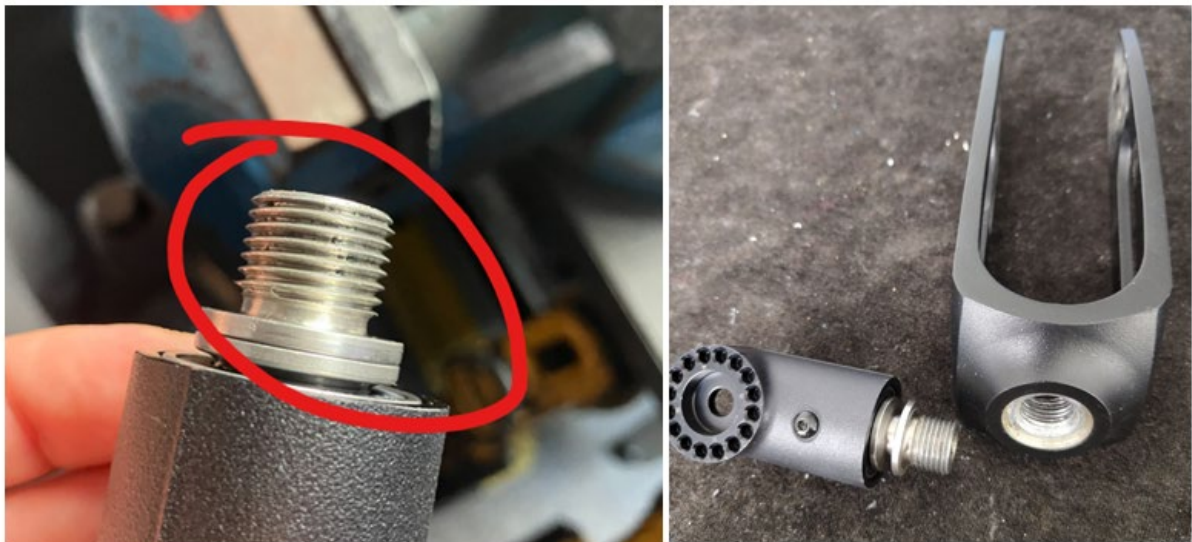
We have noted deviations in caster forks regarding thread lock and torque of the thread that is connected to the caster fork and the fork bolt. More than 80 % of the assembly groups of the identified production lot are expected to be affected.

The screw connection between caster fork and fork bolt may loosen over time and lead to loosening of the caster fork, in case this remains unnoticed. This in turn may cause the wheelchair to tip over.

Loosening of the screw connection is likely to be noticed by the user:  
Unscrewing of the fork bolt will result in an increase of the frame's height on the affected side and in a change of the seating position. Furthermore, the wheelchair will tend to pull to one side while driving.

We will contact all affected specialist dealers and provide them with a service documentation for the inspection and repair of the caster forks, as well as with a customer reply form.

Specialist dealers are asked to inform the end users of the affected wheelchairs about this corrective action and to proceed according to the service documentation.
