This Field Safety Notice (FSN) contains important customer information for patient safety and for the safe use of *exoplan*, our software for implant planning and surgical guide design.

Internal exocad Reference: #423314

exocad product, commercial name: *exoplan 3.1 Rijeka*

Field Safety Notice #423314 related to *exoplan 3.1 Rijeka*

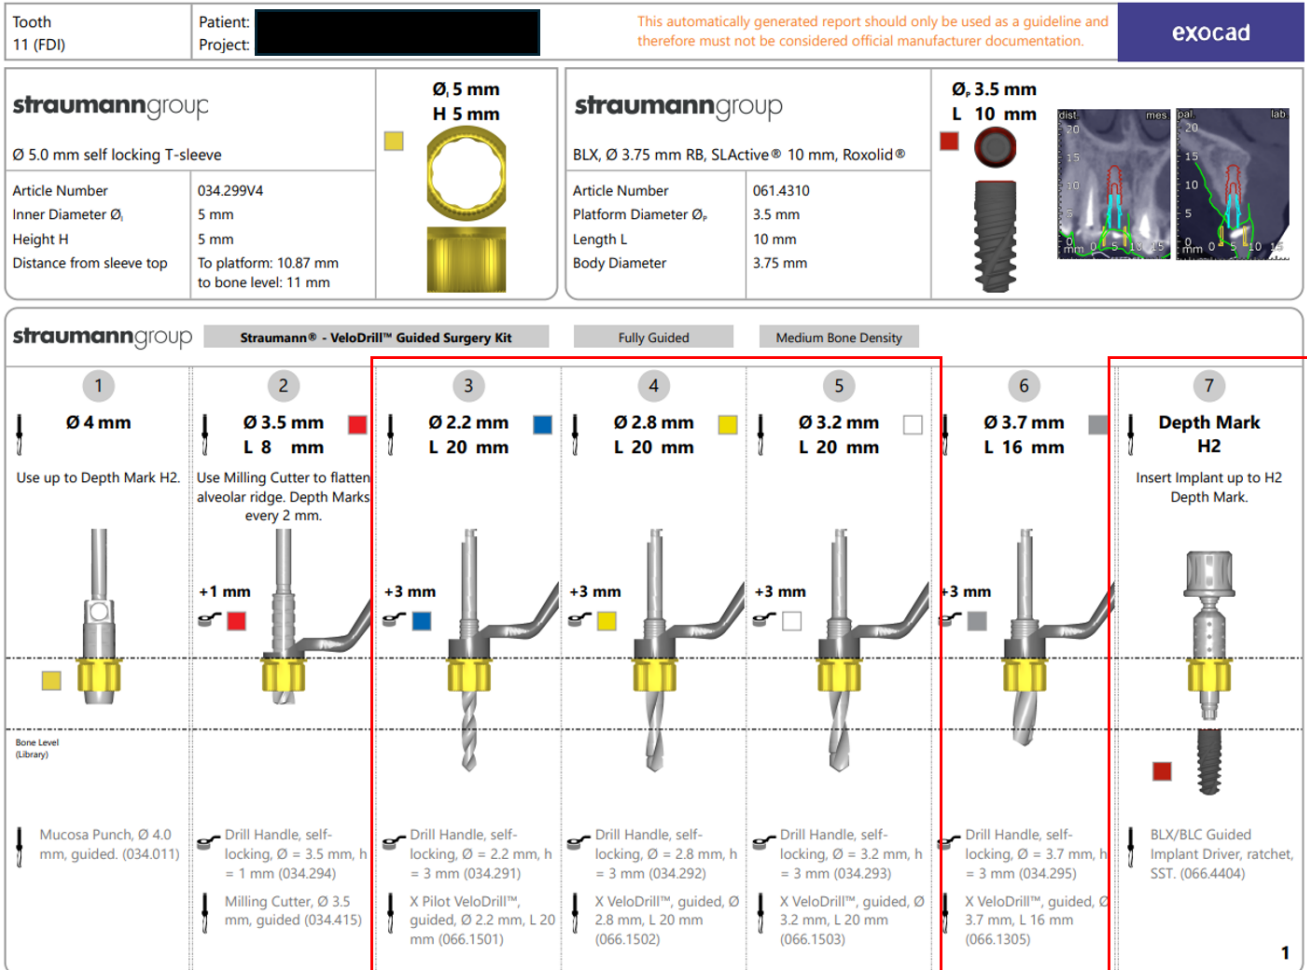
The displayed drill/tool sequence in the generated surgical report included drills with insufficient length for the planned implant position (see figure 1 below). The dentist did not notice this discrepancy prior to treatment. As a result, the prepared osteotomy was too shallow to place the implant as planned.

It is confirmed that it is a software issue and not a library issue that was already addressed in subsequent *exoplan 3.1 Rijeka* (EB 8752) or later.

Figure 1: Report from the end user who has reported the issue with the too shallow drilling. The red marked drill/tool sequence steps (no. 3-5,7) depicts the steps with the wrong (drill/tool length) information.

exocad can confirm that this issue only occurred with the legacy version *exoplan 3.1 Rijeka* (EB 8657, 8633 US, 8634 US-offline) and is resolved in *exoplan 3.1 Rijeka* (EB 8752) or later.

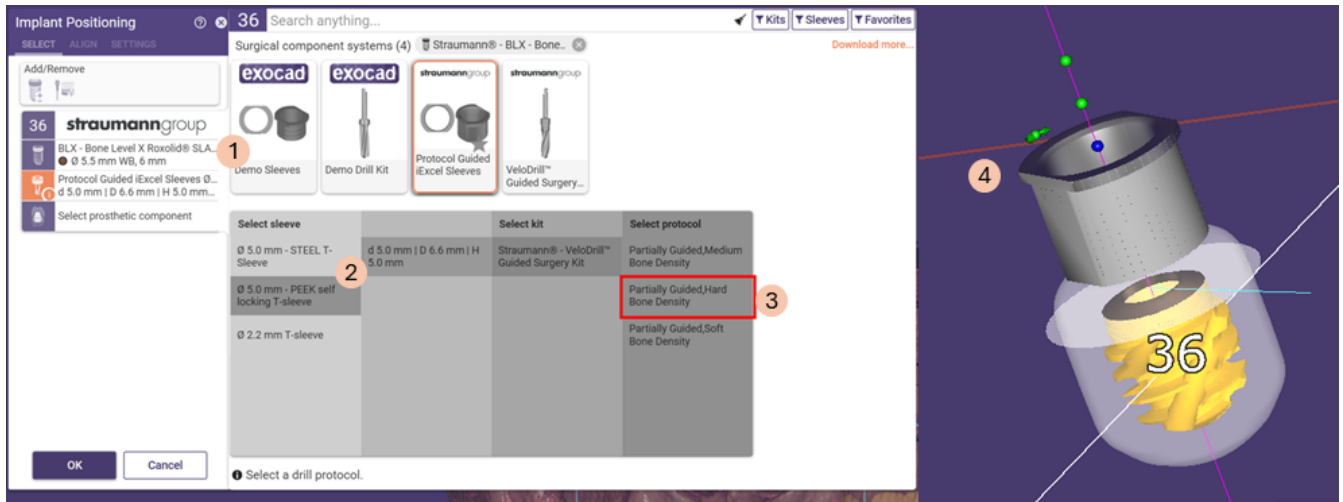
1. TLX/BLX implants with diameters of 5.5 mm and 6.5 mm and length of 6 mm (see “Affected implants” table below)
2. Ø 5.0 mm –T-sleeves (see “Affected surgical sleeves” table below)
3. Partially guided protocol, hard bone density
4. Sleeve offset 7 mm (closest of three available distances – marked as blue sphere in the figure 2 below)

Figure 2: Example of a library selection during implant planning that leads to a wrong library entry. (1) Choose one of the affected implants (see table below); (2) Select one sleeve with diameter 5.0 mm; (3) choose protocol “Partially Guided, Hard Bone Density”; (4) Choose closest distance between sleeve and implant.

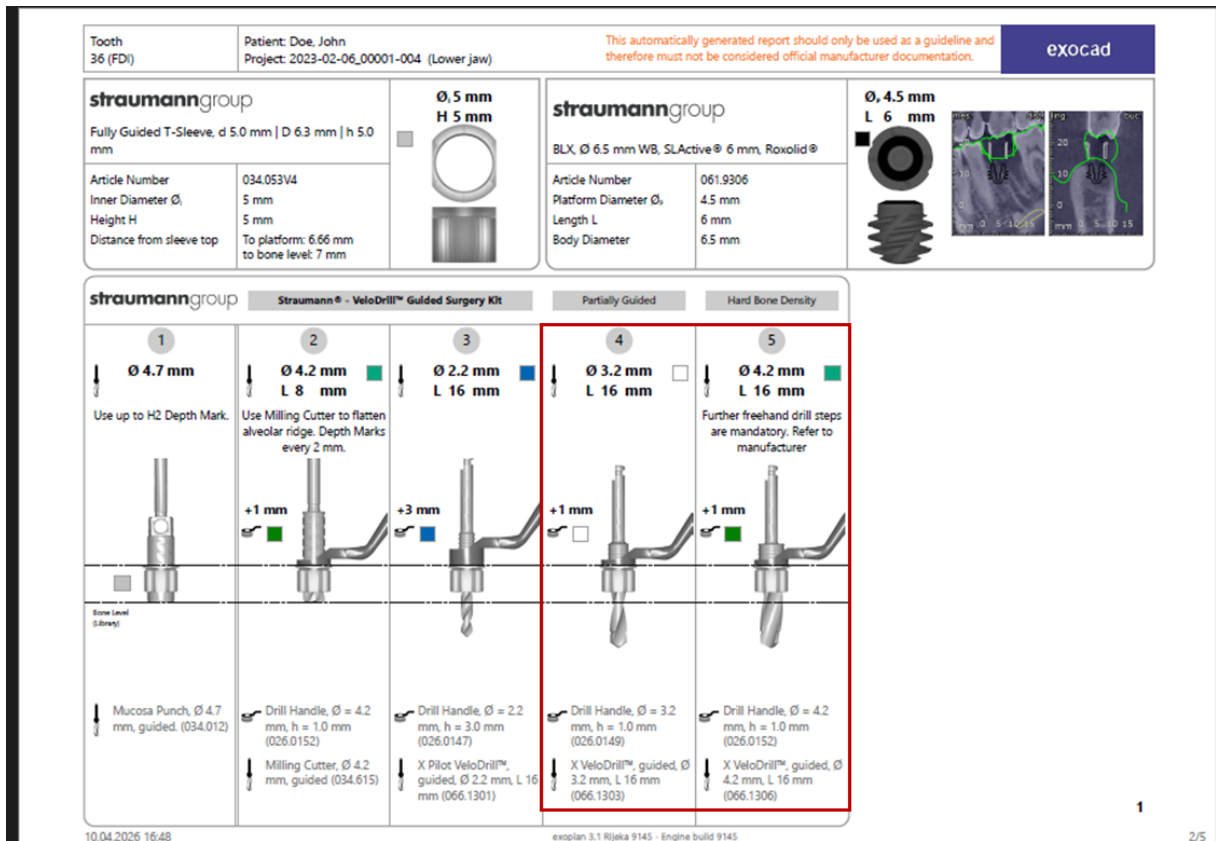
In this case, protocol steps 4 and 5 display the incorrect height of the drill handles for the used drills (marked red in figure 3 below):

Figure 3: Example step-by-step drill protocol output of *exoplan*. The drill step number 4 and 5 display the wrong drill handle (h1.0, marked red), step 3 displays the correct drill handle (h3.0).

If the incorrectly displayed protocol steps are followed, the user may select the wrong drill handle in steps four and five. This can cause the osteotomy depth to deviate 2 mm from the intended preparation depth.

- 1) Do not use the affected libraries – see section “Affected libraries” above – with *exoplan 3.1 Rijeka*.
- 2) If you are intending to use the affected Straumann® libraries, update all of them with the new, corrected versions available for download at <https://exocad.com/integration/exoplan-library-integration#/all/tag-str>.
- 3) Upgrade to the latest *exoplan 3.1 Rijeka* version.
