## Urgent Field Safety Notice

### CyberKnife® System Collimator Housing Retention Issue

May 28, 2026

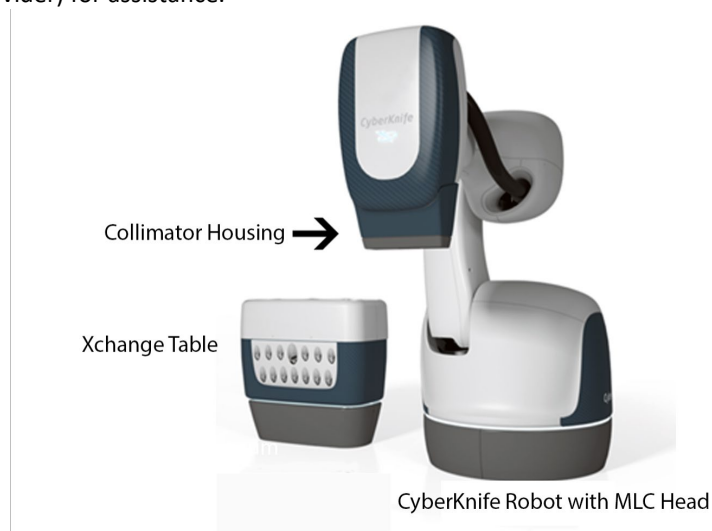
Accuray Incorporated (Accuray) identified a potential issue during CyberKnife® collimator exchange. In certain cases, during a housing exchange operation, a collimator housing may not fully latch or release. This event triggers a system interlock while over the Xchange® table that prevents motion from the operator console. In this state, the collimator housing may fall from the CyberKnife robot while over the Xchange table. In normal use, patients should be removed from the treatment room following this system interlock. While motion is prevented from the operator console, users are capable of initiating robot motion using the in-room pendant. This motion increases the likelihood of the collimator housing falling. The collimator housing is a suspended mass that may weigh up to 49 kg. This suspended mass may fall and cause injuries. The potential harm is serious injury. No injuries have been reported.

Accuray received reports of personnel entering the treatment room after the system interlock and using the in-room control pendant to initiate treatment robot motion, which can allow an incompletely latched collimator housing to release and fall. If this condition occurs, do not use the in-room control pendant to restore motion. Contact Accuray Service (or your authorized service provider) for assistance.

Figure: CyberKnife® System collimator housing location.

This condition may occur during housing drop off or pick up while the collimator housing is positioned over the Xchange table. The system will interlock, stop motion, and display a message at the operator console to contact service. If an interlock occurs: (1) remove the patient from the treatment room before troubleshooting, (2) do not initiate treatment robot motion from the in-room control pendant, and (3) contact Accuray Service to safely release the collimator housing.

Accuray is committed to providing our customers and their patients with products that deliver safe radiation treatments. Accuray will provide a product correction that limits initiating motion from the in-room control pendant when this condition is detected.
