FSN Ref: Q19C015E-08003

# Field Safety Notice RadiForce RX360 and GX560 Abnormal image displayed

# Field Safety Notice (FSN) RadiForce GX560 and RX360 Abnormal image displayed

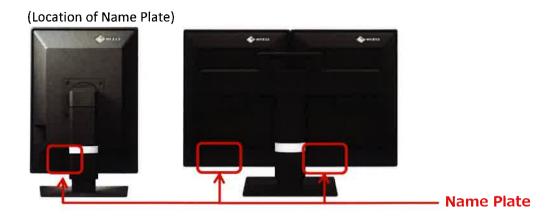
RadiForce RX360 Name Plate Sample

- 2. How to Find the Model Name, Product Code, UDI-DI, Firmware version and Serial Number (Use either of the following ways)
  - A) Referring to the name plate located on the back of the monitor.

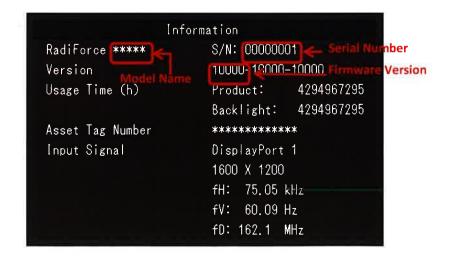
- B) Referring to the information in the monitor's Setting menu
  - i. Touch any switch (except **U**). The Operation guide appears on the screen.

ii. Select from the Operation guide. The Setting menu appears.

iii. Select "Information" from the Setting menu, then select ✓.

Model name, serial number and firmware version are displayed.
