**URGENT FIELD SAFETY NOTICE
MEDICAL DEVICE CORRECTION
FSCA 2249723-05/05/2023-008-C**

Datascope Cardiosave Hybrid and Rescue Intra-Aortic Balloon Pumps (IABP)

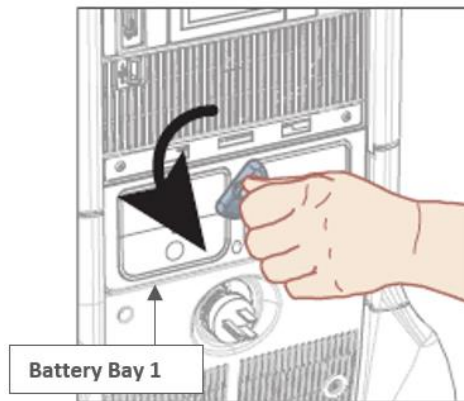
Each Battery has five (5) LEDs indicating the battery's approximate state of charge. **A battery with 80% charge is represented by four (4) solid illuminated LEDs and when charging, the topmost LED on the battery will be flashing. Removing the battery when the top LED is flashing during the charging operation may result in damage to the Cardiosave's battery charging circuitry.**

- Unplug the IABP from the wall receptacle.
- Once disconnected from AC power, remove the battery using the following instructions:
 1. Turn the knob to unlock, and remove the battery from the Battery Bay (counter-clockwise for Battery Bay 1, or clockwise for Battery Bay 2)
