Urgent Field Safety Notice

BVM (Bag-Valve-Mask) Manual Resuscitation Systems

FSCA-identifier: 170124

Date: 05 June 2017

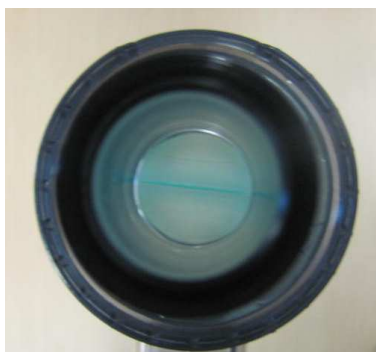
Description of the problem: There is a possibility the valve of the BVM Manual Resuscitation System may become stuck during storage. This could result in the intended tidal volume not being delivered through the valve, which may cause a delay in treatment.

Picture 2: Stuck valve

1. Ensure the valve opens prior to use when squeezing the resuscitation bag (Picture 1).
2. If the valve is stuck (Picture 2), squeeze the bag fast and firmly to open the valve (Picture 3).
3. If the BVM Manual Resuscitation System contains a pressure relief valve (Picture 1) manually hold this closed to prevent it from opening when squeezing the bag. Repeat action 2 whilst the pressure relief valve function is overridden.
4. Make sure the valve is now open and fully functional prior to use.

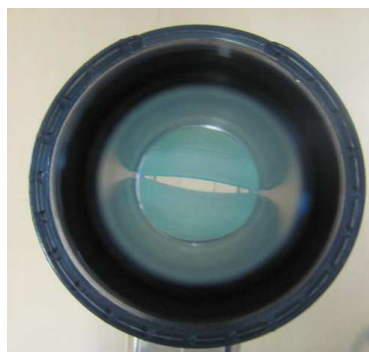
Picture 3: Open valve
