[Month DD, YYYY]

**URGENT FIELD SAFETY NOTICE
MEDICAL DEVICE CORRECTION**

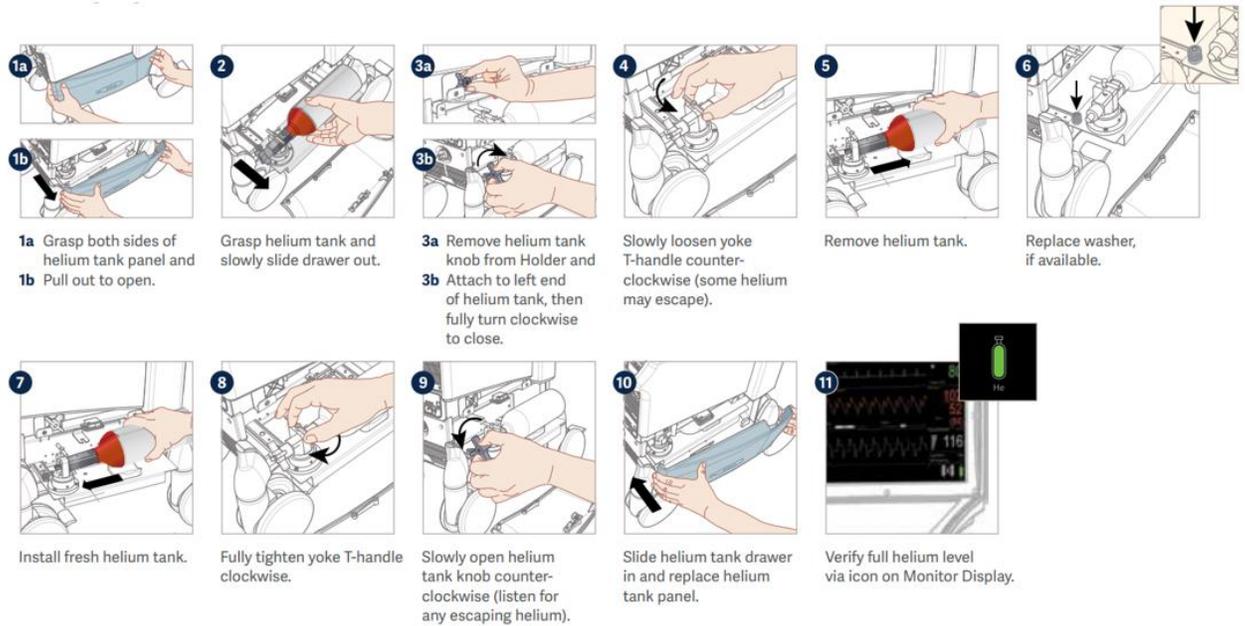
Figure 2: As pictured in **Cardiosave Hybrid and/or Rescue Operating Instructions**
