**URGENT Field Safety Notice**  
**Risk of Leakage when using Purge Cassette Gen 1**

<b>1. Information on Affected Devices*</b>	
1.	1. Device Type(s)* Purge Cassette
1.	2. Commercial name(s)* Impella Purge Cassette
1.	3. Primary clinical purpose of device(s)* The purpose of the purge system is to continuously drive fluid (typically 5% glucose solution in water with heparin or sodium bicarbonate) through the motor to lubricate the bearing and prevent the ingress of blood into the motor. When the purge cassette is properly installed in the Automated Impella Controller, the Abiomed® logo is upright and facing you. The purge fluid is delivered by the purge cassette housed within the AIC through the pump exiting just below the impeller forming a pressure barrier to deflect the blood that the impeller is pulling through the cannula.

2.	1. Description of the product problem* Abiomed, Inc. has initiated a device recall (removal) of Purge Cassette (Gen 1) due to the availability of an updated Purge Cassette (Gen 2) with lower risk of purge leaks. The purge cassette delivers rinsing fluid to the Impella catheter. The purge fluid flows from the purge cassette through the catheter to the mic

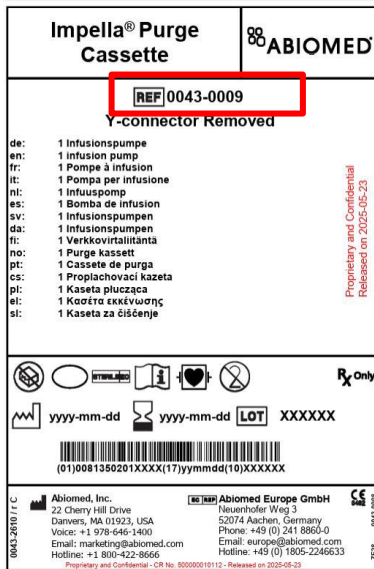
- For Impella 5.5 pump set, not all pump sets are impacted. **Impella 5.5 pump set (1000482) is not impacted.**
- For Impella 5.5 pump set (0550-0002) and Impella RP (0046-0011), open the pump set and look for the purge cassette with code (0043-0009) as shown in the image below:

- ✓ :1000851: No action required
- ✗ : 0048-0014: open the Pump-Set, remove the Gen 1 Purge Cassette (0043-0009), and follow the instructions in **ACTIONS TO BE TAKEN BY CUSTOMER/USER:**

Once the impacted pump sets are identified, open and look for the purge cassette with code (0043-0009).
