URGENT FIELD SAFETY NOTICE

RESOLVE[®] HALO

FSCA – 032021

STERILE PACKAGING INSPECTION INSTRUCTIONS

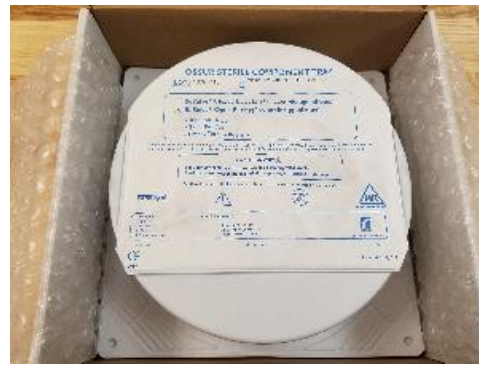
PICTURE OF THE DEVICE PACKAGING

Össur is committed to providing safe, high-quality medical devices to its customers. Össur's Halo devices have sterile barrier systems that contain high impact polystyrene trays with sealed Tyvek lids. It has been identified that the high impact polystyrene trays of Resolve® Halo Rings and Össur Halo Rings may crack or puncture during transit, leading to a potential failure of the sterile barrier system. As such, Össur is implementing a Field Safety Corrective Action in relation to the sterility risk and the packaging inspection steps required for the affected Halo devices.
